THE GILBOA DAM AND ITS POSSIBLE FAILURE:  
WHAT IT MEANS FOR NYC AND UPSTATE NEW YORK

Submitted in partial fulfillment  
of the requirements for  
Honors in the Department of Environmental Studies  
UNION COLLEGE  
June, 2008

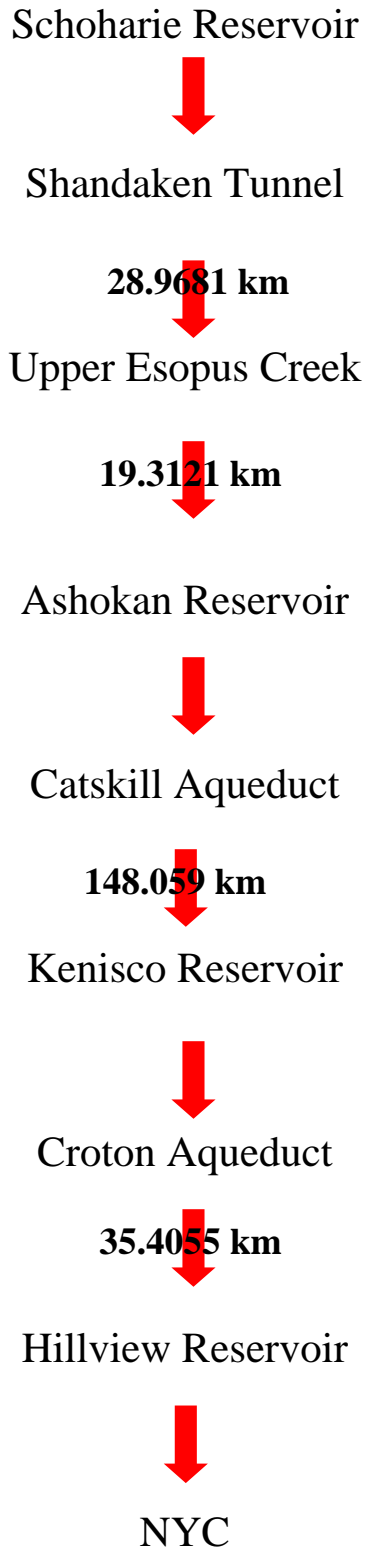
Figure 7. Course of water from the Schoharie Reservoir to NYC (Catskill Watershed Corporation, 2005; Cornell Cooperative Extension et al., 2007)

The water that will eventually travel to NYC is first collected in the Schoharie Reservoir, providing 16 percent of the City's water supply (NYC DEP 3, 2007). The majority of this water is from the Schoharie Creek, 75% of it, but two smaller streams also flow directly into the reservoir, the Manor Kill and the Bear Kill, providing the remainder of the water within the reservoir (NYC DEP 8, 2007). From the Schoharie Reservoir, the water is then withdrawn via an intake chamber in the north end of the reservoir into the Shandaken Tunnel, where the water is transported 28.9681 kilometers and released into the upper portion of the Esopus Creek. The Esopus Creek drains into

the Ashokan Reservoir, which is part of the Catskill Aqueduct System that then travels on to the Kenisco Reservoir. Ultimately, this system drains from the Croton Aqueduct into the Hillview Reservoir in Westchester County, which is the final storage point before the water is distributed within the NYC water supply (Figure 7; Cornell Cooperative Extension et al., 2007).

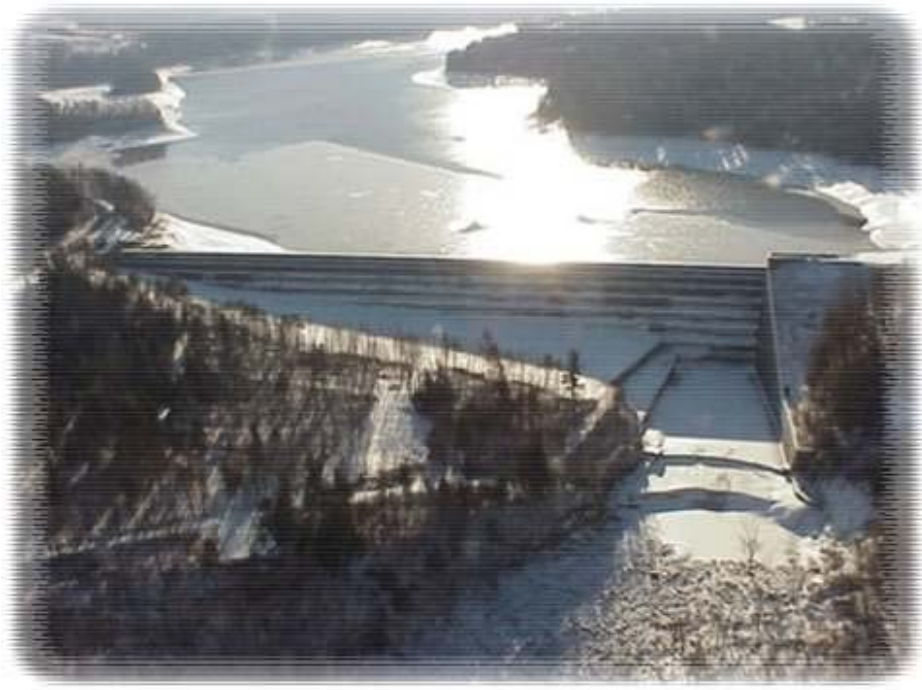
Figure 8. Gilboa Dam and the Schoharie Reservoir (Pytlovany, 2006)

The Gilboa Dam is composed of an earthen embankment and a concrete spillway (NYC DEP 7, 2007; Figure 8). Embankment dams are completely made of natural materials, typically either earthfill or rockfill. This type of dam is the most common throughout the United States. It relies solely on its weight to resist the force of the water and it also has a waterproof core that prevents any water seepage from occurring through the structure (PBS, 2001). In the case of the Gilboa Dam, it is comprised of earthfill, but also has a concrete spillway (NYC DEP 7, 2007). A spillway is an overflow channel that allows the release of water when it gets high enough to threaten the safety of the dam (PBS, 2001).

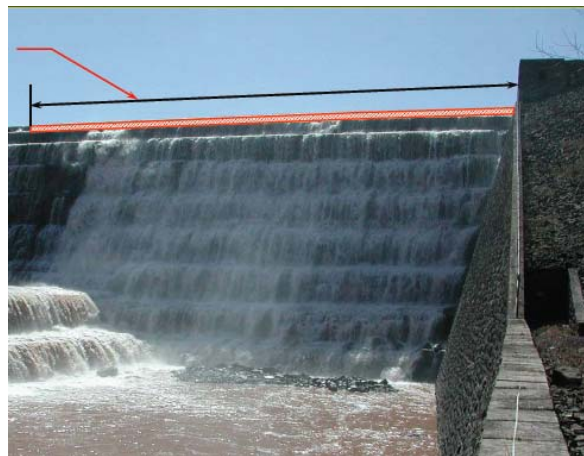
Figure 14. Placement of the notch (arrows) that was removed from the Gilboa Dam (NYC DEP 9, 2007).

The NYC DEP's short term plan for the dam involved monitoring and several stabilization improvements. The majority of this short term plan was completed in 2006 and was a \$24 million project (NYC DEP 4, 2006). The first step toward the completion of this project was the installation of a debris boom across the top of the Gilboa Dam. The purpose of the debris boom was to keep outside material off of the dam in order to make sure no extra fragments were adding pressure to the structure and the work site for reconstruction would be clean as well (NYC DEP 10, 2007). The next progression of the NYC DEP's plan was the removal of a notch from the western end of the dam that was 67 m long and 1.68 m high (Figure 14) (Michaels, 2006).

With the Gilboa Dam's old spillway system, before the notch was added, peak inflow behind the dam was  $1133 \text{ m}^3 \cdot \text{s}^{-1}$  and peak outflow over the dam spillway was  $1019 \text{ m}^3 \cdot \text{s}^{-1}$ , which would only mitigate a ten year flood by 10 percent. After the notch was installed, however, the NYC DEP reported peak inflows of  $566 \text{ m}^3 \cdot \text{s}^{-1}$  and  $680 \text{ m}^3 \cdot \text{s}^{-1}$  being reduced to  $255 \text{ m}^3 \cdot \text{s}^{-1}$  and  $510 \text{ m}^3 \cdot \text{s}^{-1}$ , which is a mitigation of 55 and 25 percent respectively. Thus, just the installation of the notch has resulted in a significant improvement of the Gilboa Dam's flood mitigation ability (DCC 72, 2007). The installation of this notch also lowered the capacity of the Schoharie Reservoir, which in turn decreased the amount of pressure occurring behind the Gilboa Dam and ensured a dry area upon which further renovations could take place (Michaels, 2006).

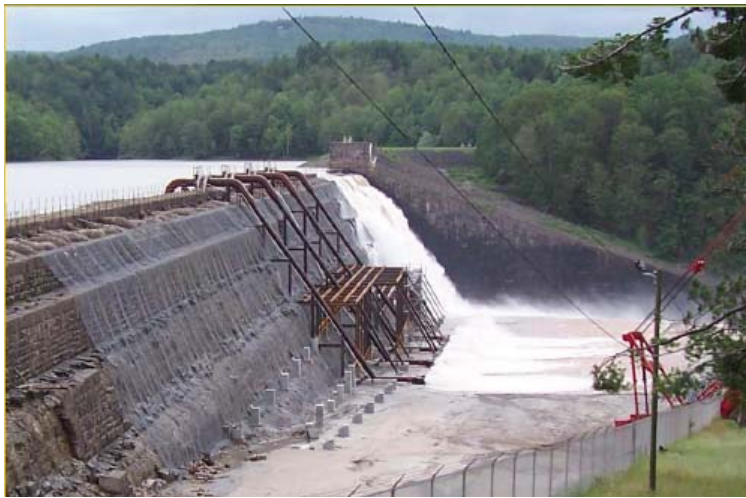
Figure 15. Gilboa Dam after the siphons were installed as part of the NYC DEP's short term reconstruction (NYC DEP 9, 2007).

To lower the Schoharie Reservoir level even further in preparation for the full-scale reconstruction of the Gilboa Dam, part of the NYC DEP's short term plan was to also install four large siphons, which could potentially remove up to 472.18 million liters of water per day (Figure 15). With the combined effect of the 4 siphons and the notch, enough water was being released from the Schoharie Reservoir to allow the final stage of the interim reconstruction to take place. In this final stage, 79 anchoring cables were installed in parts of the Gilboa Dam thought to be the most unstable, which included areas along the top of the dam and some farther downstream as well (Michaels, 2006). In order to set up these cables, workers had to drill holes into the dam, some straight into the bedrock and some at an angle, for each cable (DePalma, 2005). Each cable was then anchored to both the dam and the bedrock at the bottom of each drilled hole and tightened to create tension that would help keep the dam in place (Michaels, 2006). According to Paul Rush, the deputy commissioner of the Bureau of Water Supply, this kind of a repair

has worked on thousands of other dams and is a step in the right direction to stabilizing the Gilboa Dam (DePalma, 2005). In fact, the anchoring work brought the Gilboa Dam within the safety standards required for existing dams by the New York state DEC (Michaels, 2006).
